REPORT No. T 6/59

OPERATION ANTLER

The Effects of Blast on Dummies and Scout Cars

August, 1959

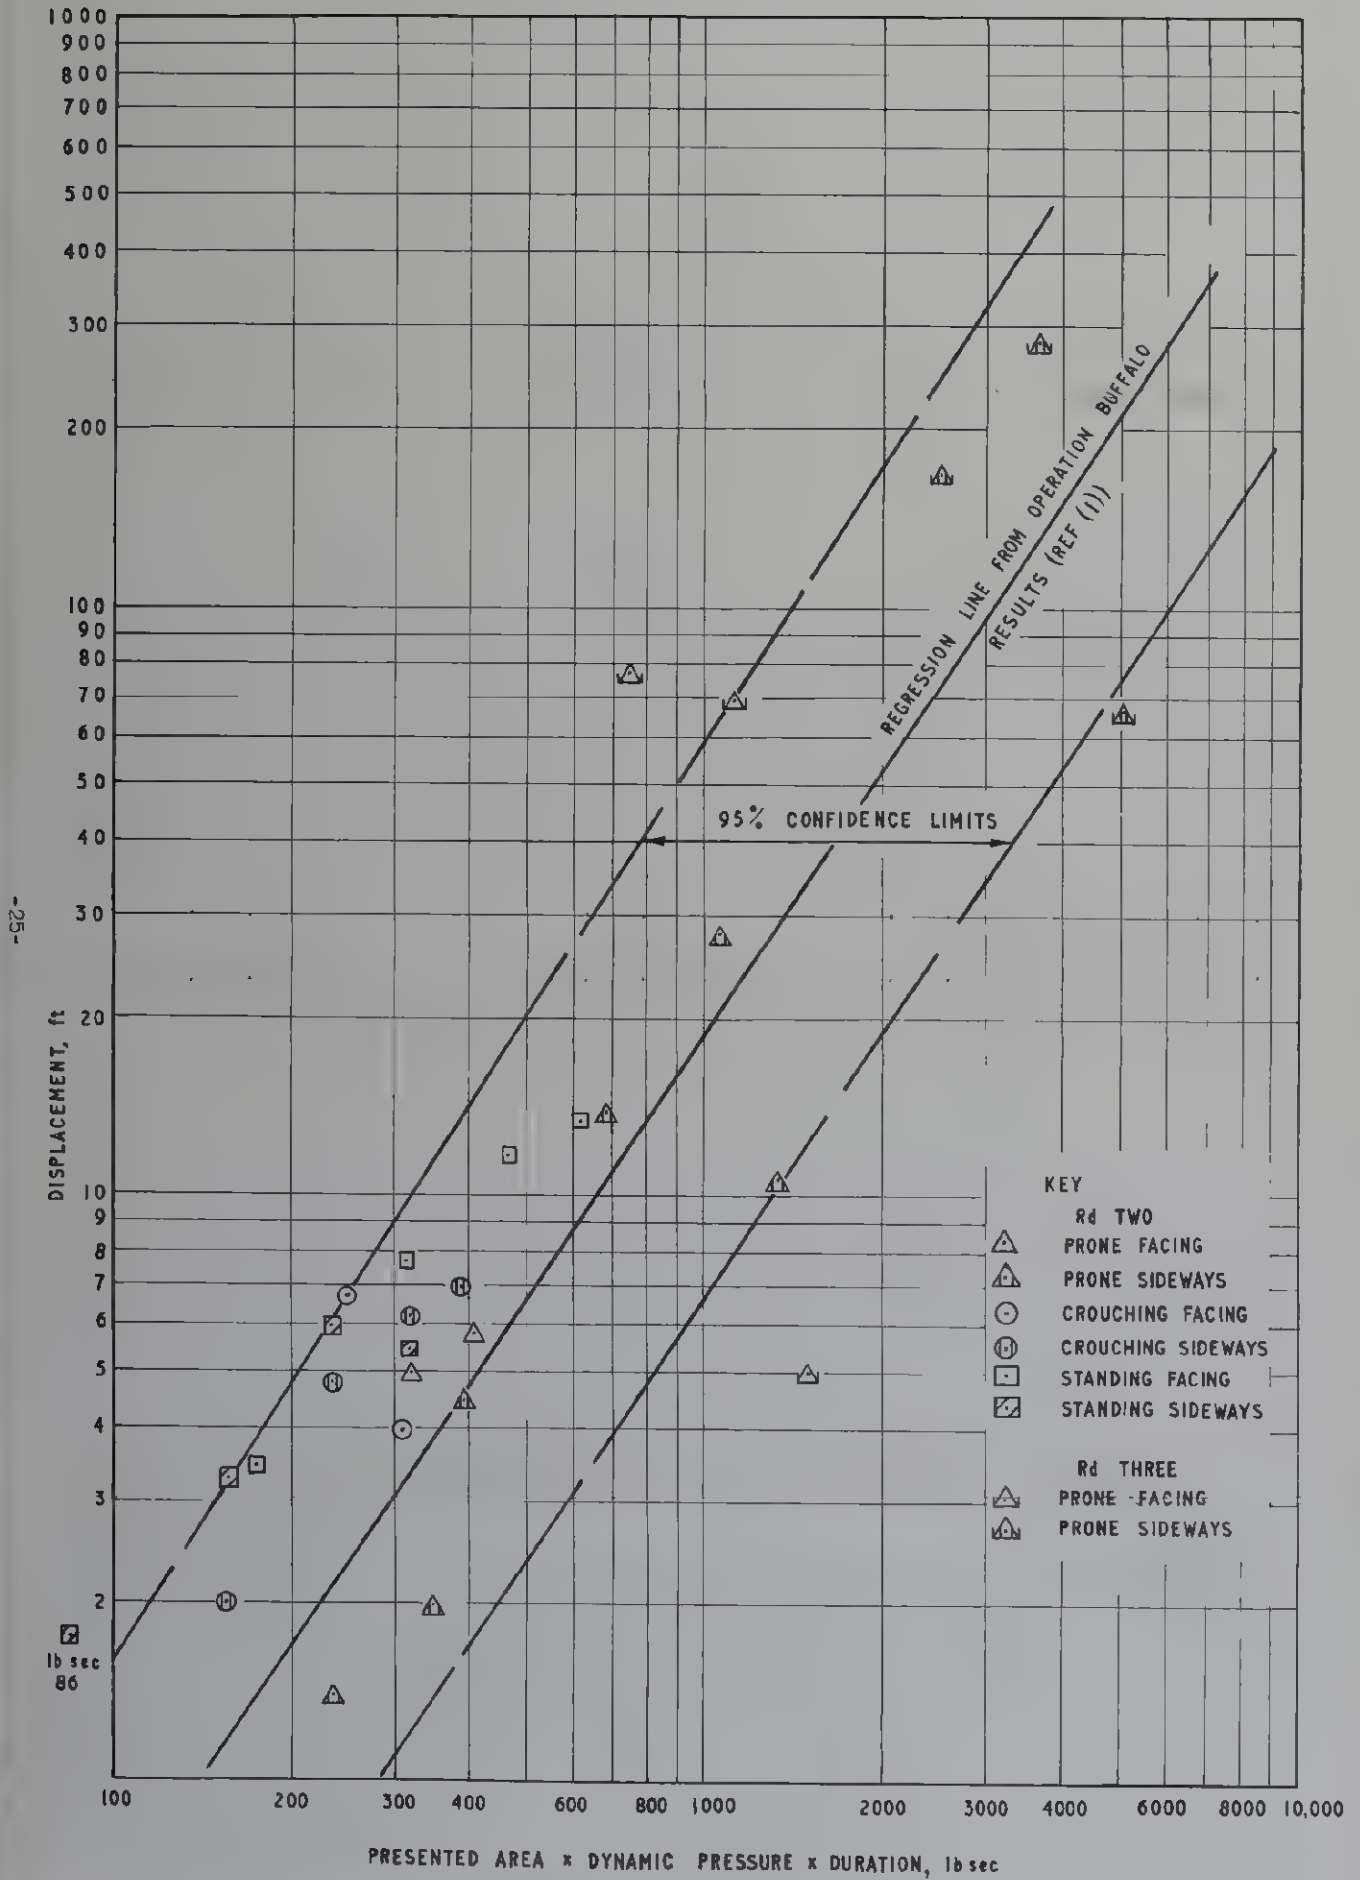
FIGURE 1

If Figure 1 the displacements of the dummies have been plotted against a quantity - the product of the peak

dynamic pressure, the positive phase direction and the presented area, which is proportional to the impulse received by the dummies. The quantity is not the impulse itself, since it takes no account of the hydrostatic pressure rise of very short duration, the drag coefficient of the dummies, or the decay of the dynamic pressure to zero at the end of the positive phase. The regression line with 95% confidence limits obtained from similar results from Operation Buffalo has also been drawn on the Figure.

Agreement between Operation Antler and Operation Buffalo results is fair, bearing in mind that three weapons of different yields and heights of burst are involved. Too close an agreement between dummies in different postures is also not to be expected. A prone dummy if sideways to the blast will tend to roll, whereas if facing Ground Zero it cannot do so until other movement has taken place. A dummy prone facing will have considerably greater frictional resistance to motion. However, inspection of Figure 1 fails to show displacements of dummies prone sideways to be significantly greater than those prone facing, considering the greater area presented by the former.

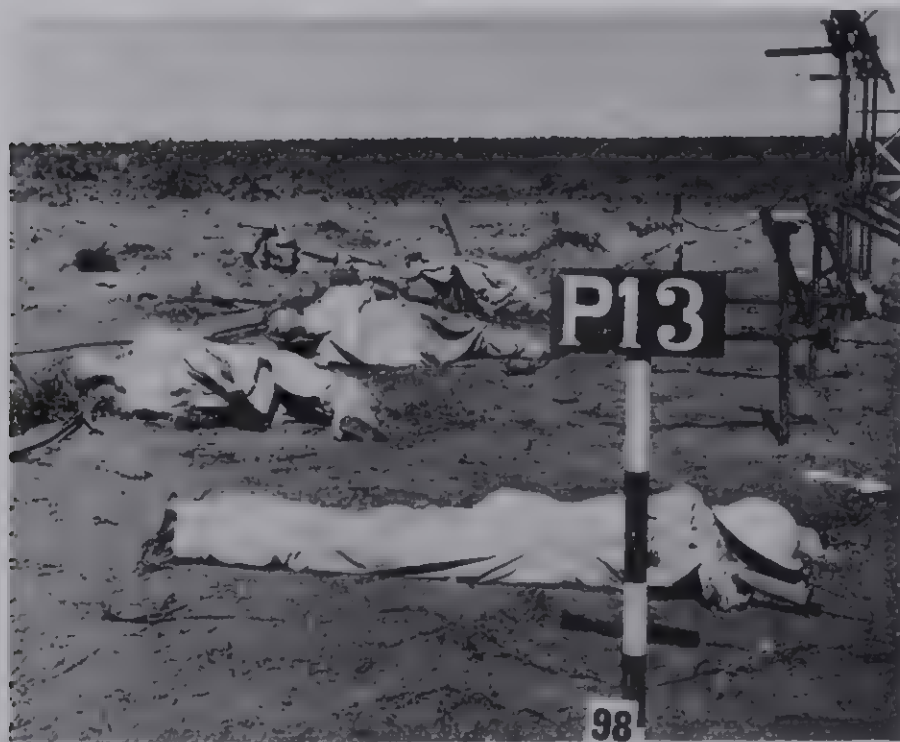
FIGURE 11. ROUND 2. DUMMIES AT 2390 ft AFTER FIRING.
NOTE CAMERA TOWER IN BACKGROUND, AND
LACK OF MOVEMENT OF THE PRONE FACING DUMMY

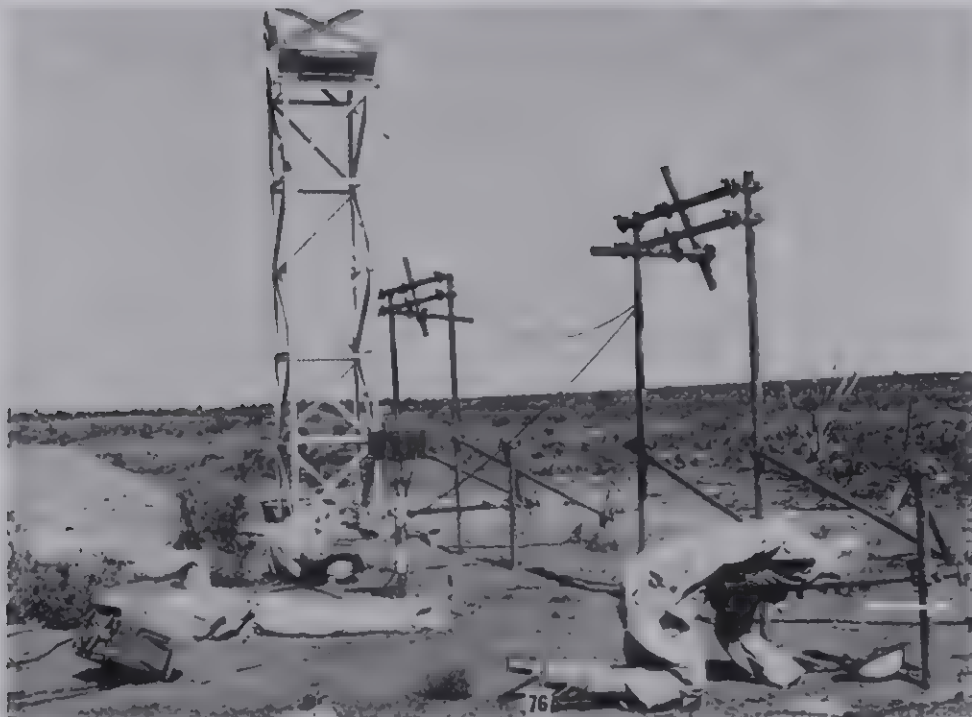
FIGURE 12. ROUND 2. DUMMIES AT 3100 ft AFTER FIRING. NOTE
CROUCHING FACING DUMMY HAS REMAINED ON THE
SUPPORT AND HELMET HAS DROPPED OFF AFTER
POSITIVE PHASE

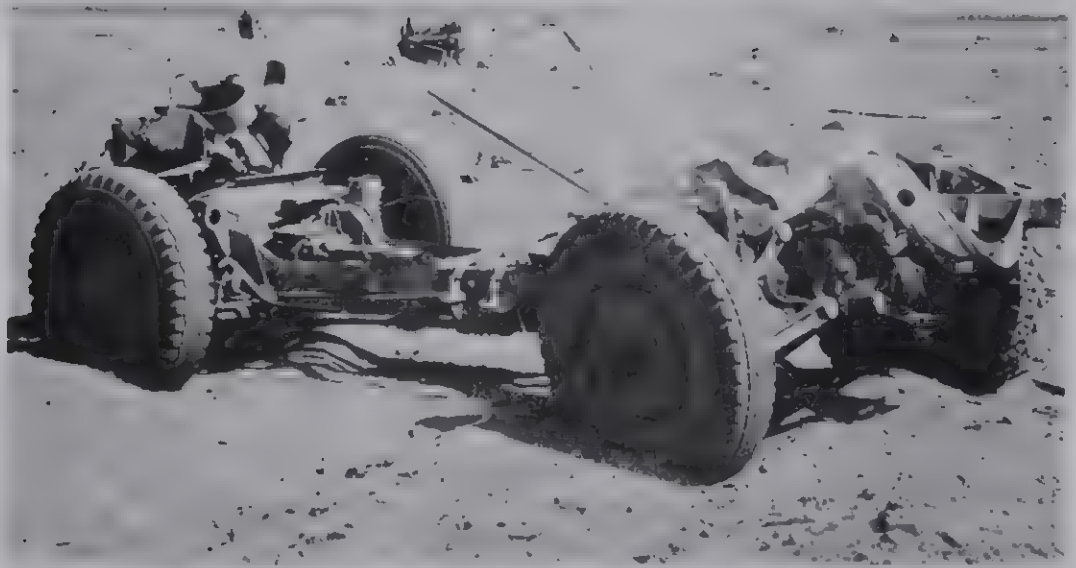
FIGURE 16. ROUND 3. VIEW OF FRONT 4 CHAMPS AFTER FIRING
WITH SCATTERED DEBRIS

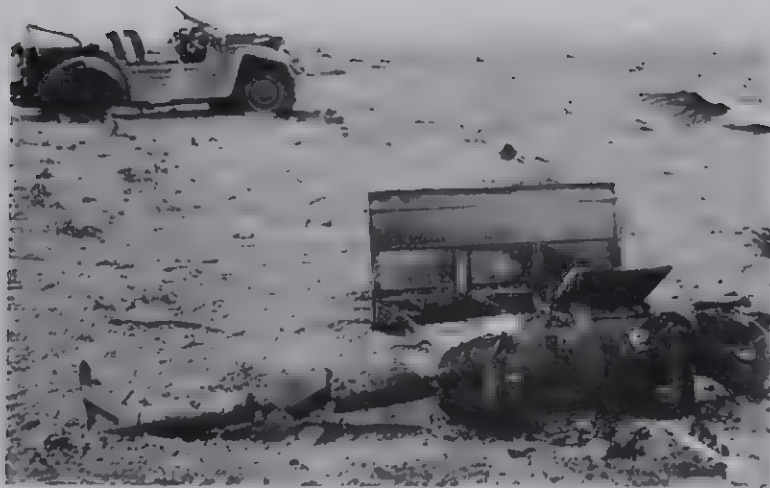
FIGURE 18. ROUND 3. DUMMY PASSENGER FROM CHAMP
SIDEWAYS TO BLAST AT 2825 ft BURNT OUT
AND WITH ONE LEG MISSING

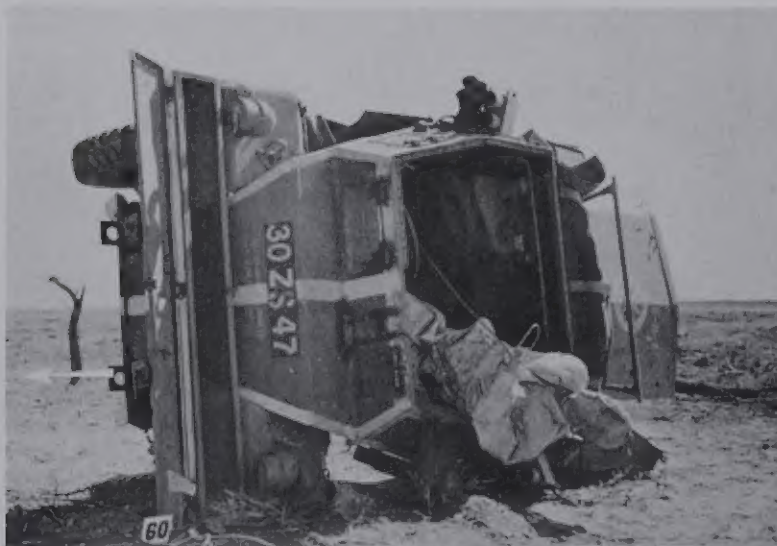
Because the yield of the weapon actually fired was much lower than had been assumed in the initial target response planning, only minor damage was done to the Scout Cars and so little new data were obtained. However, the critical conditions for overturning a Daimler Scout Car sideways on to the blast were bracketed by the car at 1730 ft from Ground Zero of Round 2 was turned over while the one at 2360 ft was not.

FIGURE 21. ROUND 2. SCOUT CAR AT 1730 ft AFTER FIRING.
NO APPARENT DAMAGE TO DUMMY OR SCOUT CAR
WHICH SIMPLY TURNED OVER ONTO ITS SIDE

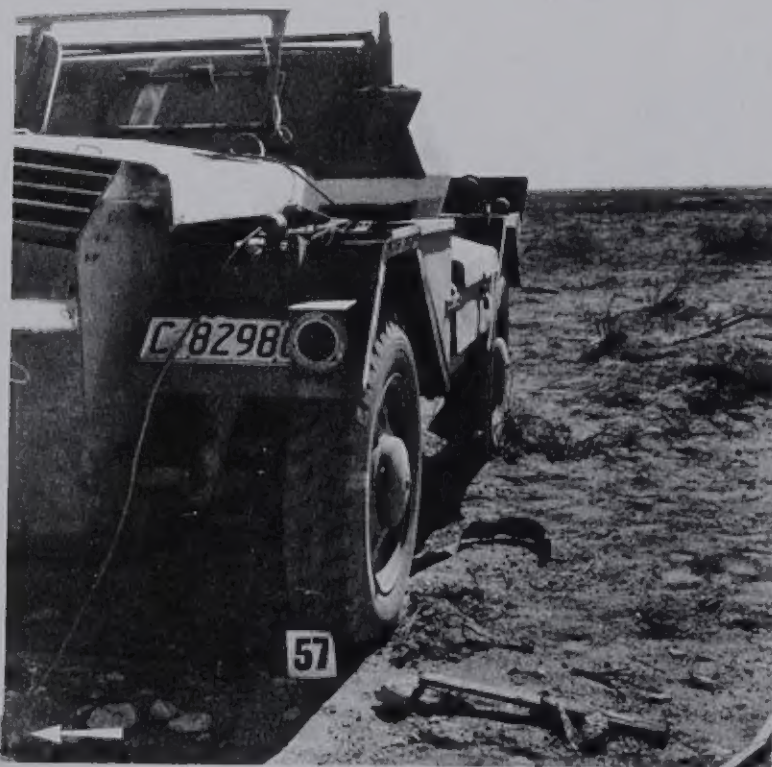
FIGURE 22. ROUND 2. SCOUT CAR AT 2200 ft AFTER
FIRING. NOTE SOIL DISPLACED BY WHEEL
WHEN CAR MOVED SIDWAYS 4 INCHES

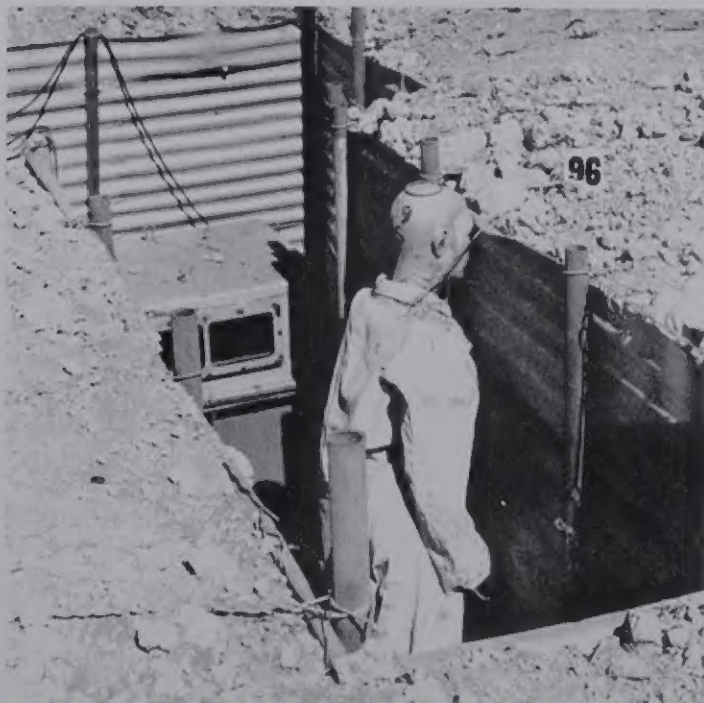
On Round 2, one dummy was standing in a trench which was at right angles to the radius from Ground Zero at Site P17 (2390 ft). The dummy was facing Ground Zero with the rim of its steel helmet about level with the lip of the trench (see Figure 23). This dummy was exposed primarily to test a camera installation, but after firing it was observed that it had not moved and had apparently suffered no damage (see Figure 24).

FIGURE 24. DUMMY IN TRENCH AT 2390 ft AFTER FIRING
